## Project Title

3D Printing Assisted Surgery and Custom Prosthesis for Saving a Great Pied Hornbill

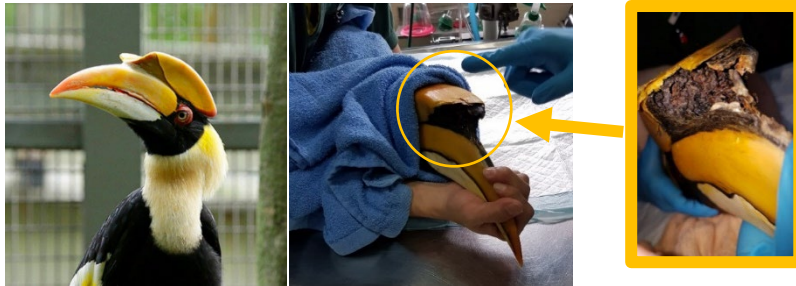
A normal great pied hornbill (left). The infected casque of great pied hornbill in JBP (right).

A great hornbill in Jurong Bird Park was diagnosed with cancer in its casque. Surgery was required to remove the cancer tissue, which involved the removal of a large portion of the bird's casque. As survival of the hornbill is unlikely with a significant loss of its casque, an artificial one is required to ensure the bird can live post-surgery.

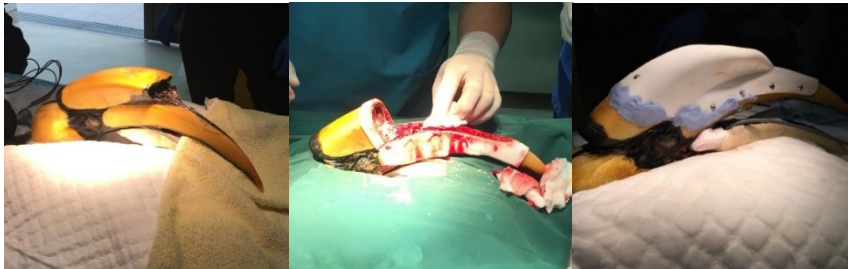
The surgery was successfully performed. Surgical guide (middle) and prosthesis (right) were designed based on CT data and fabricated at AM.NUS.

The surgical guide and prosthesis were successfully designed by the team from Keio-NUS cute centre using CT scans of the hornbill and manufactured at AM.NUS. Nylon was chosen as the material of choice as it is lightweight and biocompatible.
